RESTORATION PLAN

BLACKLOCK RESTORATION PROJECT

Suisun Marsh, Solano County, California
SRCD Ownership #635

Prepared By
Division of Environmental Services
California Department of Water Resources

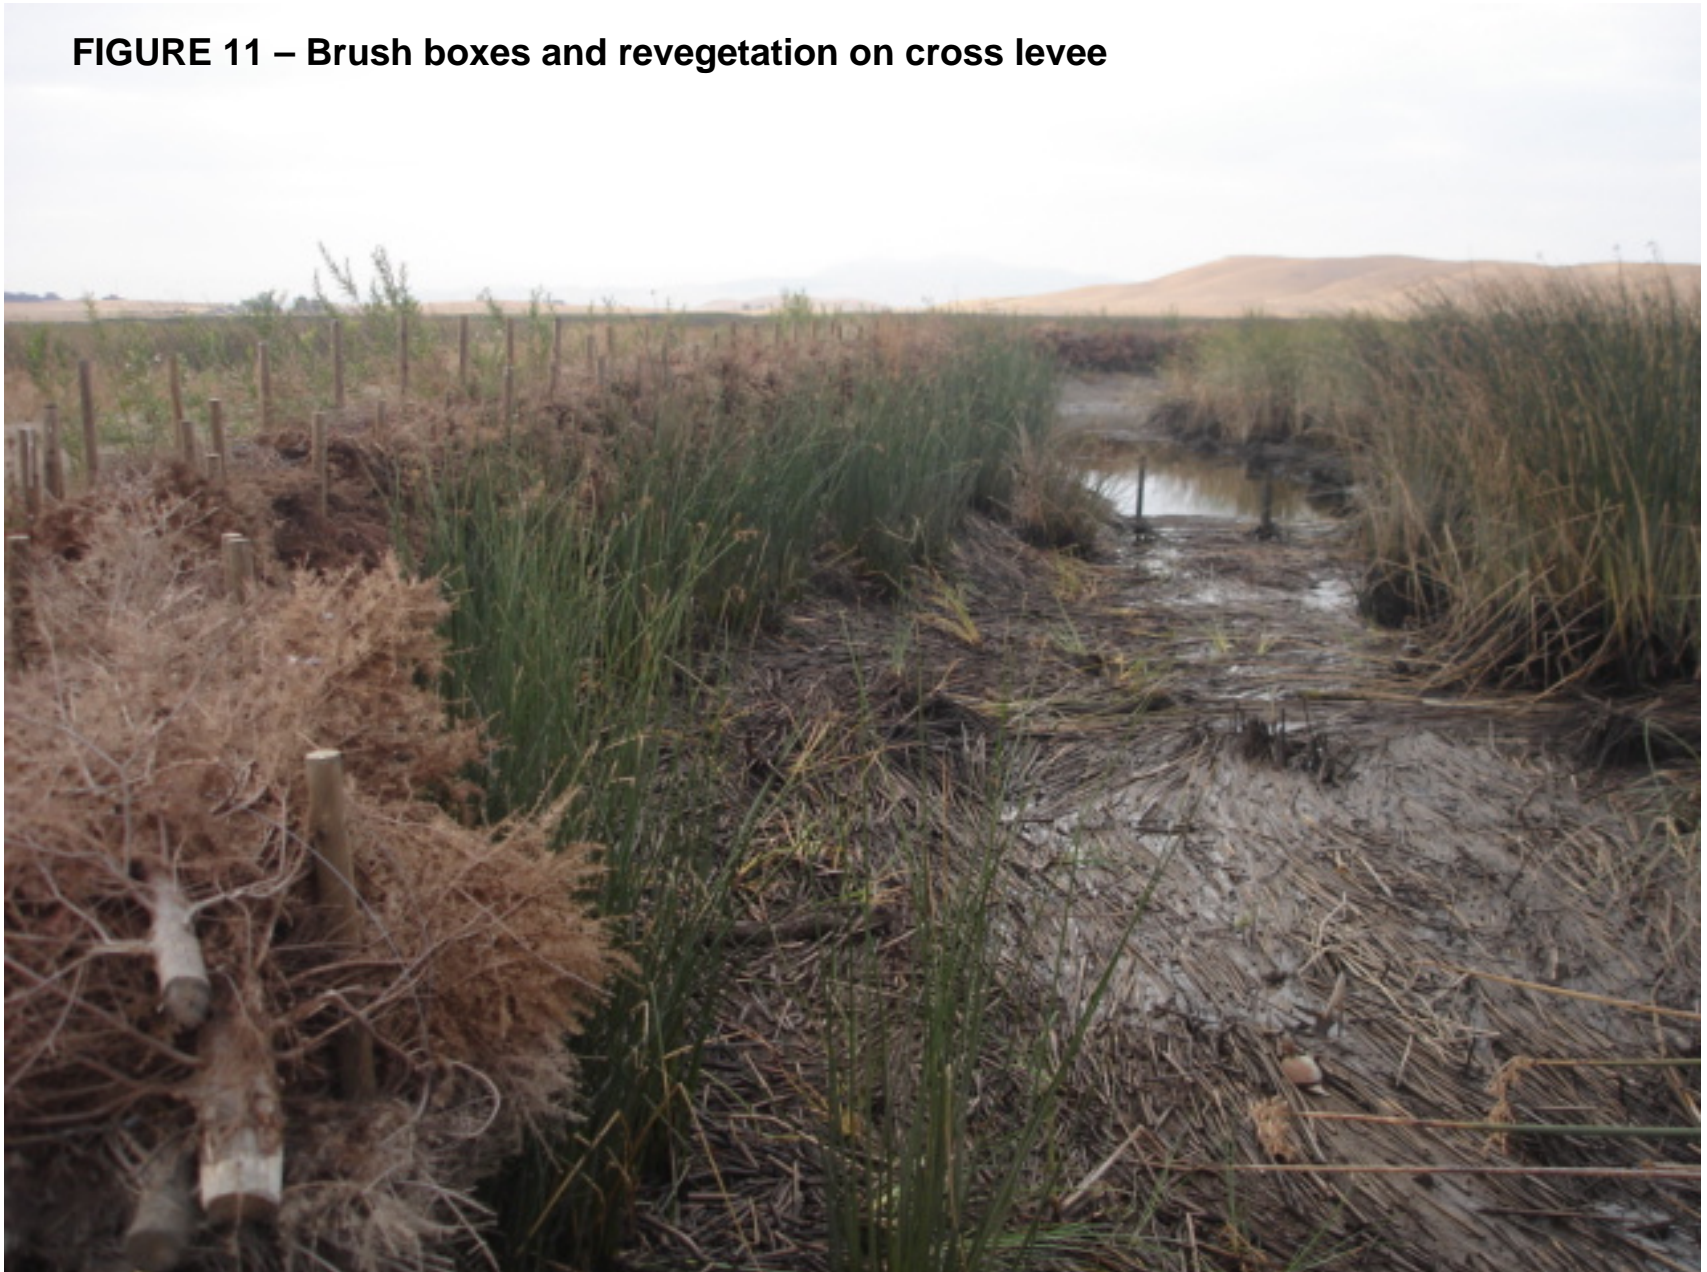
FIGURE 11 – Brush boxes and revegetation on cross levee

To protect the levee slope from wind and wave erosion, brush boxes were installed on the cross-levee slope in early 2006 as an alternative to rip rap. Brush boxes are constructed by driving 2 parallel rows of 3-inch diameter wooden poles along the levee slope. Recycled Christmas trees were placed between the poles and secured in place (Figure 11). This method has been used successfully in other areas of Suisun Marsh and in the Sacramento-San Joaquin Delta.

The base of the cross-levee was revegetated with *Schoenoplectus californicus* in 2005 (Figure 11). This species will remain viable during the winter months. In addition, woody vegetation was planted on the levee slope above the brushboxes. The brushboxes are expected to provide erosion protection for 3-5 years, giving time for the revegetated levee to mature. This alternative approach to protect the levee slope will be evaluated for effectiveness. If the brushboxes do not provide adequate protection, additional measures will be considered.
